EARTH MOVEMENT IN ETHIOPIA:

This article is in reference to the recent earth failure or “sinkhole” under the main road south of Sheshemenie, Ethiopia. Per the report by the Ethiopian National Disaster Risk Management Commission, dated April-May, 2016 (Meazia 2008), it measured 50 meters (165 feet) wide and 50 meters deep, which would be equivalent to approximately 16 floors of a building (See pictures below). The sinkhole is said to continue east, towards the rift valley. The paper will discuss the general geologic conditions of the area, possible reasons of the movement and some viable engineering solutions. The intention is not to address all historical earthquake data and damages that might have occurred in Ethiopia, but to inform and remind the public of the earth shaking that is occurring, so the country can better prepare and minimize any future fatalities or economic devastations.

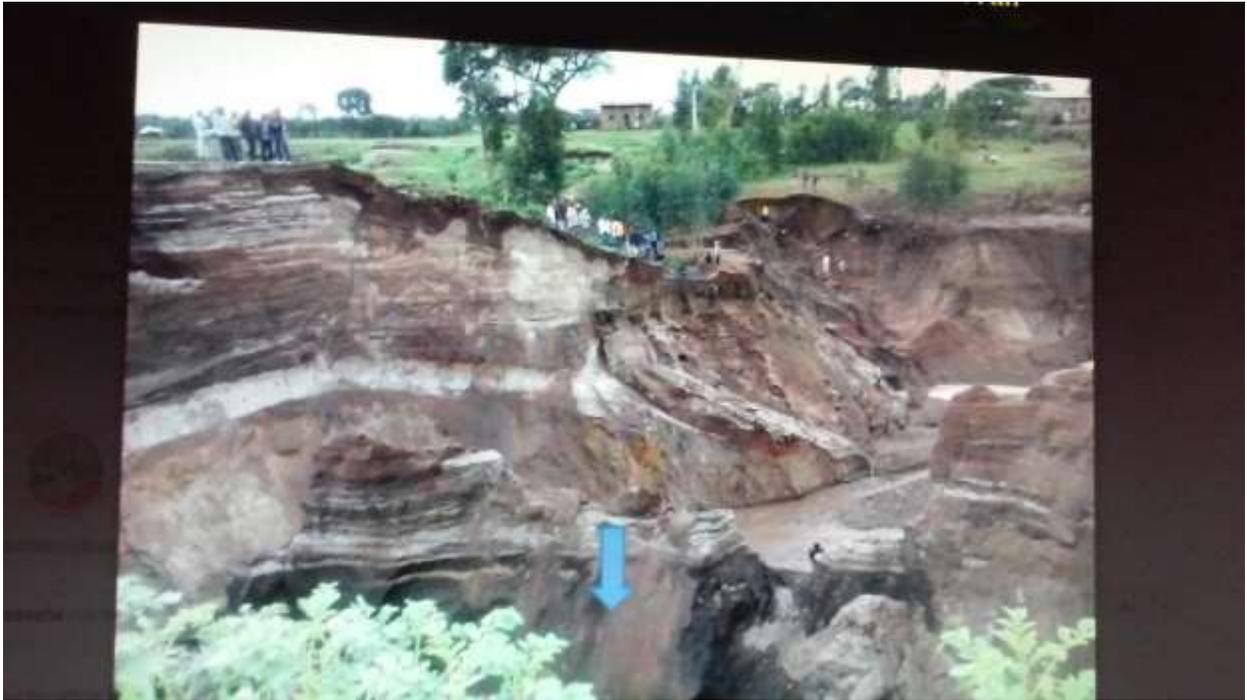
The existing asphalt concrete roadway is gone.

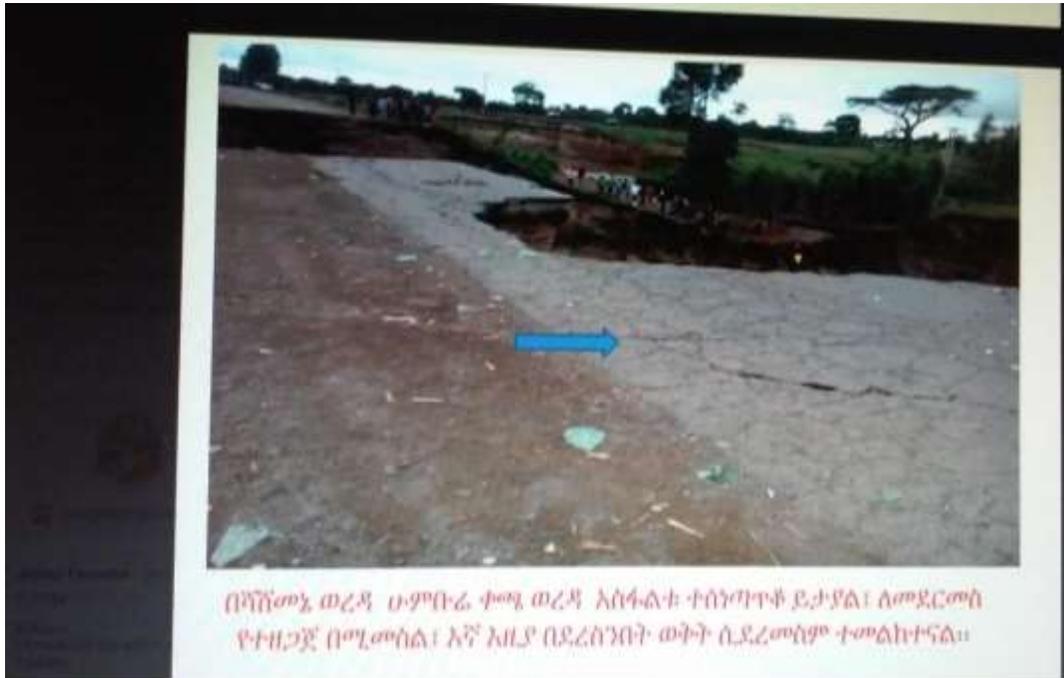
Note from an eye witness who saw the collapse of the road from the crack (above).

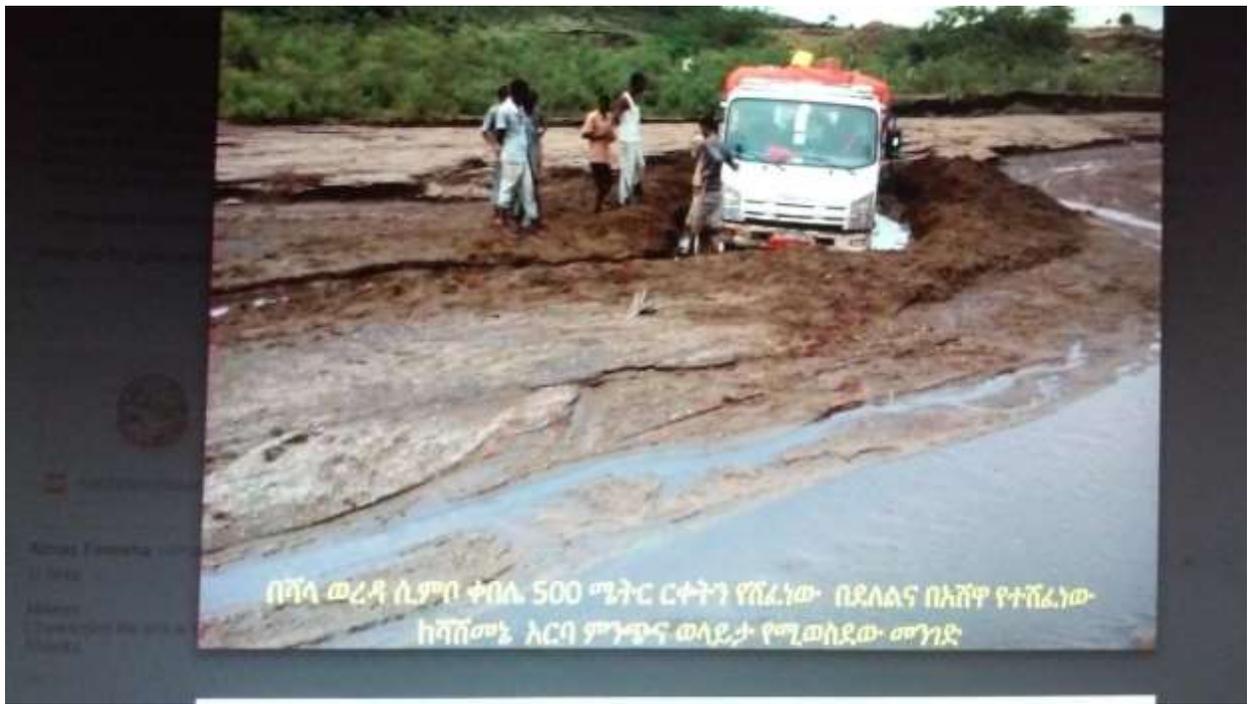
በሻላ ወረቃ ሲምቦ ቀበሌ 500 ሜትር ርቀትን የሸፈነው በደለልና በአሸኞ የተሸፈነው ከሻሸመኔ እርባ ምንጭና ወላይታ የሚወሰደው መገንደ
